## **Failure Analysis of a Sucker Rod from an Oil Well Located Offshore Trinidad and Tobago**

Failure analysis was performed on one of several fractured sucker rods that failed at the stress relief length of the pin-shoulder and the thread of the rods during the fit-up alignment and torque assembly of the rod strings and the couplings. Optical microscopy, scanning electron microscopy and microprobe analysis were utilized to characterize the mode(s) of failure and to analyse the fractured surfaces and inclusions. Brittle flat fractured surfaces were observed for more than 80% of the cross section of the rod. Multiple initiation points of failure propagated from the circumference of the rod which contained machine/grinding marks and a multitude of minute cracks. Microstructure close to the surface of the rod showed transverse cracks propagating from inclusions which were analysed to be manganese sulphide. Torsional load applied to the rod during the assembly added to the stress points on the surface. These surface defects then coalesced into one crack front which propagated in a transgranular shear mode of failure. The recommendations included discontinuing the use of the sucker rod

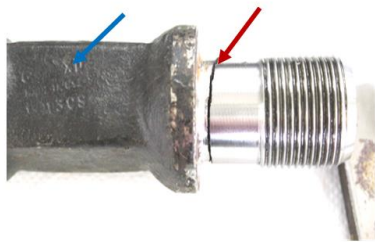
#### Figure 1

The visual inspection of sucker rods revealed that the fractures occurred closer to the shoulder of the stress relief region between the pin shoulder and the threads of the rods. The stamped letters on the wrench square section indicated the type of rod. There were no markings indicating the rods' specifications and year of manufacture. The typical fracture position is shown (Figure 1). The fractured cross-section was relatively flat with a brittle mode of failure for more than 80% of the rod and ductile section that indicated final fracture zones. There were also severe abrasions in the ductile regions. A typical fracture is shown (Figure 2).

*Fracture at Shoulder (red arrow). Note wrench square section (blue arrow).*

Visual examination of the failed sucker rods from an oil-well offshore Trinidad and Tobago showed that the fracture occurred closer to the shoulder of the stress relief region between the pin shoulder and the threads of the rod (Figure 1). Further examination showed that failure emanated from surface features on the rod (Figures 4 & 7). These features created multiple initiation sites for cracks to nucleate, propagate and coalesce to form one crack front showing a brittle transgranular shear mode of failure for more than 80% of the diameter of the rod (Figures 2, 3, 10 & 11) and then parted to depict a tensile overload ductile mode of failure. The ductile region subsequently experienced mechanical damage in the form of abrasion marks post failure. Small sections of micro-void coalescence were observed on the fractured surface in areas of the ductile region (Figure 12).

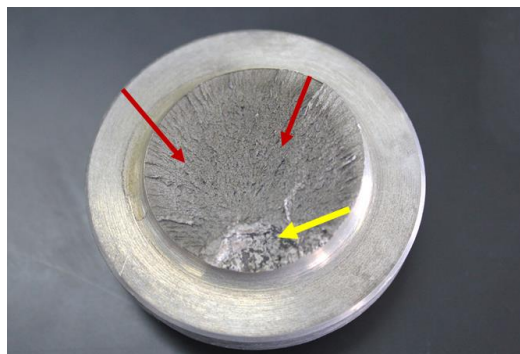
#### Figure 2

The fractured cross-section is flat and brittle (red arrows); fast fracture severe abrasion (yellow arrow).

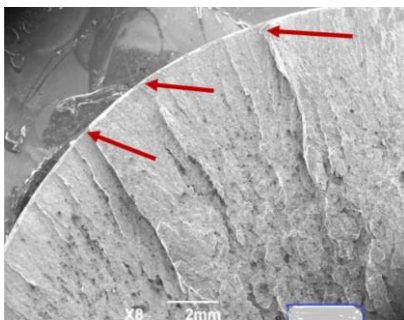
**Figure 3**

Macro analysis of the sample revealed that the fractured surface showed multiple crack propagation sites (Figure 3). The surface of the rod also showed machine/grinding marks and a multitude of minute cracks emanating and propagating along these processing marks close to the fractured regions (Figure 4).

*Multiple crack propagation sites on the circumference of the rod (red arrows).*

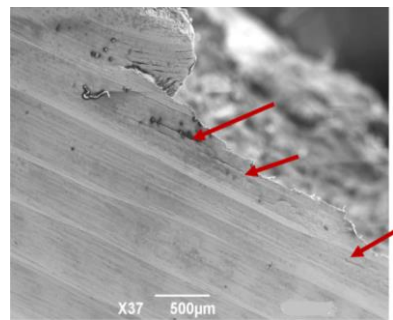
**Figure 4**

*Minute cracks emanating close to the fracture region (red arrows).*

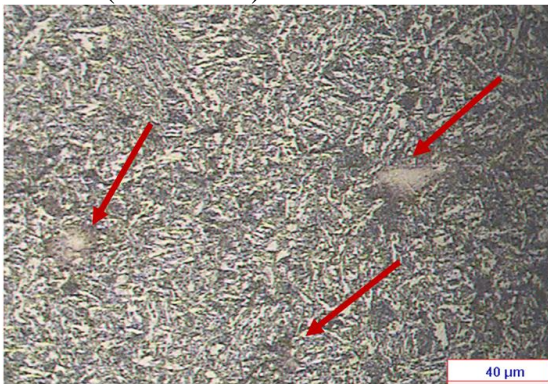
**Figure 5**

Sections of the sucker rods were ground, polished and etched, and microstructure revealed a fine-grained normalized and tempered structure. Also of note was the high inclusion level in the matrix (Figure 5). Longitudinal sections close to the main fracture showed transverse cracks propagated perpendicular through the axis of the rods in transgranular modes. The feature is seen in Figure 6.

A typical microstructure. Note high inclusion content (red arrows)

Metallographic analysis of the rod showed a normalized and tempered microstructure, that contained a number of inclusions having different sizes and shapes and randomly oriented throughout the matrix (Figures 5, 7, 8 & 9) including the surface and subsurface. The inclusions were identified as sulphides and oxides, with the majority being manganese sulphide compounds (Figures 14 & 15). It should be noted that the shape of the inclusions plays an important part in determining whether notches can be created to encourage stress points for fatigue to initiate. Cracks were observed propagating from the irregular-shaped inclusions that “emanated” to the surface of the rod and propagated along the machine/grinding marks that were also observed on the surface of the rod (Figures 4, 7, 10 & 13). The cracks then propagated through the axis of the rod along lines of least resistance, that is, the irregular-shaped inclusion sites within the matrix of the steel (Figures 6 & 9).

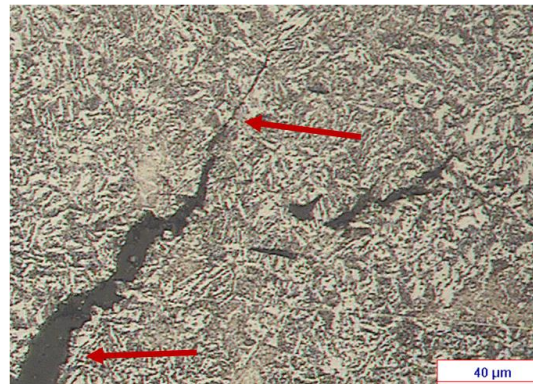
**Figure 6**

A transverse crack propagating (red arrows).

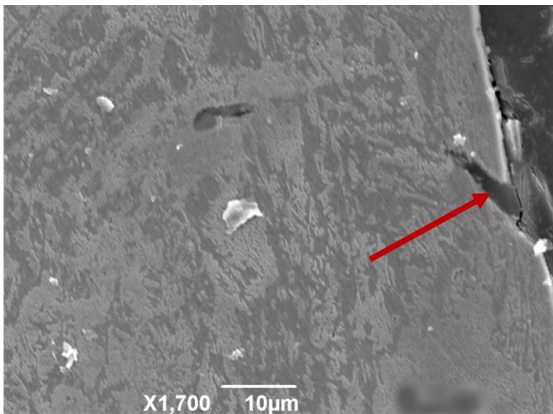
**Figure 7**

SEM analysis of longitudinal sections close to the fractured regions showed typical features of a transverse crack propagated from an inclusion at the surface of the rod (Figure 7). There were inclusions in the matrix that were greater than 200 μm in width (Figure 8). Secondary cracks propagated along the lines of the stringer inclusions. Also of note was cracking at the inclusion interface and spaces where inclusions were once lodged (Figure 9).

A transverse crack propagated from an inclusion at the surface (red arrow).

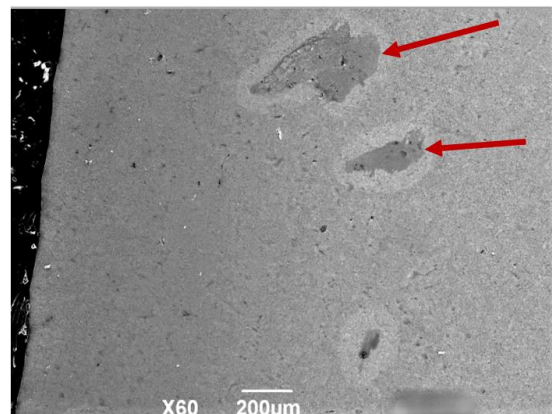
**Figure 8**

Inclusions greater in width than 200 μm (red arrows).

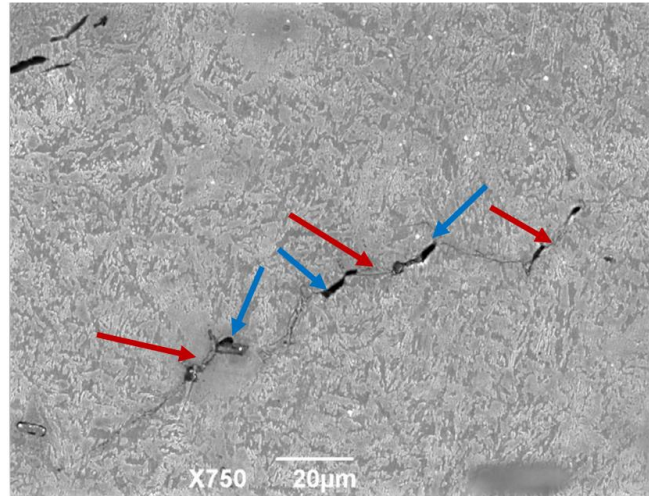
**Figure 9**

*Cracks Propagating along the Lines of the Stringer Inclusions (red arrows). Also note inclusions have fallen out of the matrix (blue arrows).*

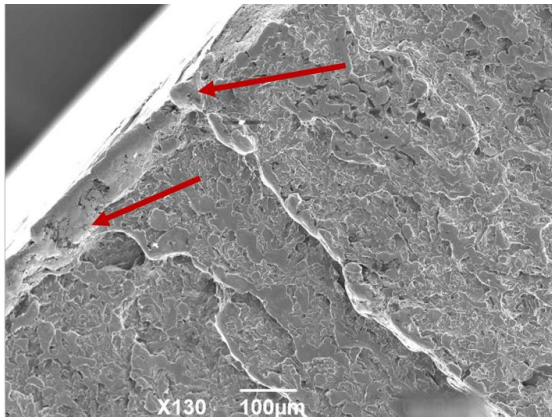
A fractograph of the rod revealed multiple cracks propagated from machine/grinding marks at the surface (Figure 10). Figure 11 is a fractograph showing a brittle transgranular shear mode of failure. The final fracture zone showed ductile micro-void coalescence within the mechanically damaged (abraded) region (Figure 12). Multiple crack openings at inclusions and machine/grinding marks on the circumference of the rod adjacent to the main crack are shown in Figure 13.

**Figure 10**  
*Multiple Cracks Propagating from Machine/grinding Marks (red arrows).*

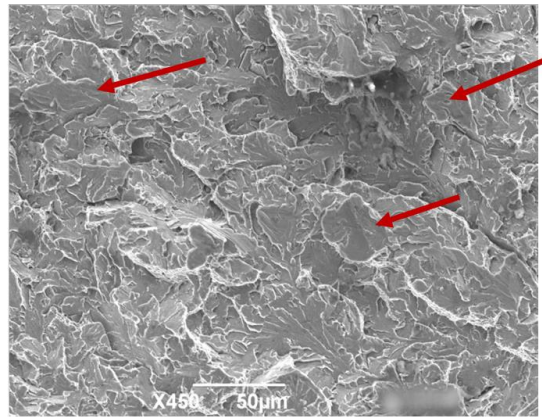
**Figure 11**  
*A Brittle Transgranular Shear Mode of Failure (red arrows)*

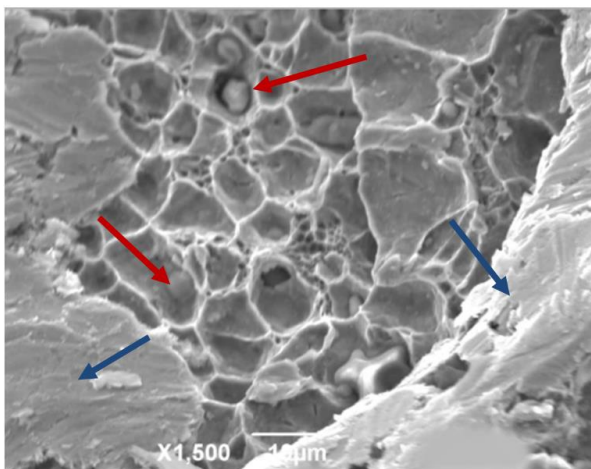
**Figure 12**  
*Micro-void coalescence (red arrows) within abraded region (blue arrows).*

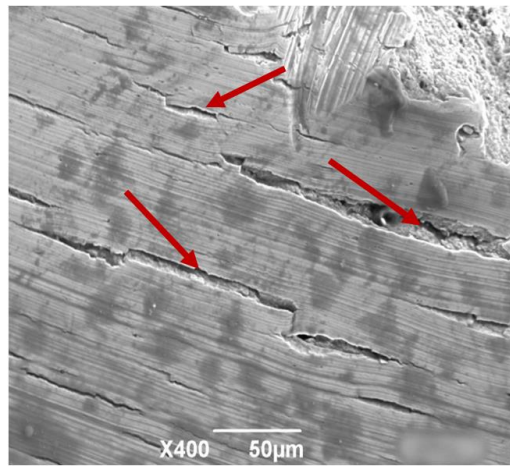
**Figure 13**  
*Multiple crack openings at inclusions and machine marks (red arrows).*

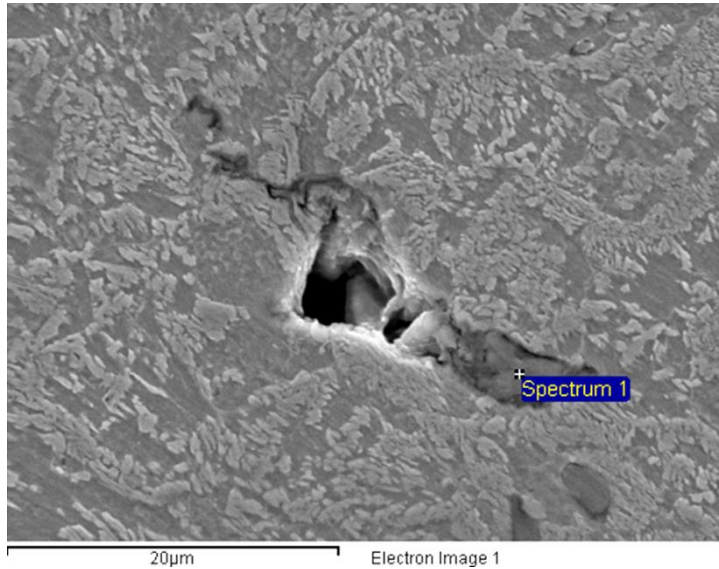
**Figure 14**

Microprobe analysis of samples revealed stringer-like inclusions that were analysed to be manganese sulphide. Also of note was cracking at the inclusions and the voids that followed (Figure 14). Circular shaped inclusions were also analysed to be manganese sulphide with a trace of oxygen (Figure 15).

*Stringer like inclusion showed the compound manganese sulphide and also showed cracking and a void.*

Element	Weight %
Si	0.44
S	33.95
Mn	52.04
Fe	13.57
Totals	100.00

Fatigue cracks may also initiate through the inclusion cracks, or they may initiate from the interface between the different phases of the inclusion (Figure 14). Fatigue crack initiation is dependent on the stress concentration factor of the defect. Differences in the thermal expansion coefficients of the inclusion and the matrix can generate internal stresses around inclusions (Niclas et al., 2015). During the hot working of the steel, the stresses between inclusions and the steel matrix are relaxed, but when cooling occurs, tensile residual stresses are generated around the inclusions which causes problems.

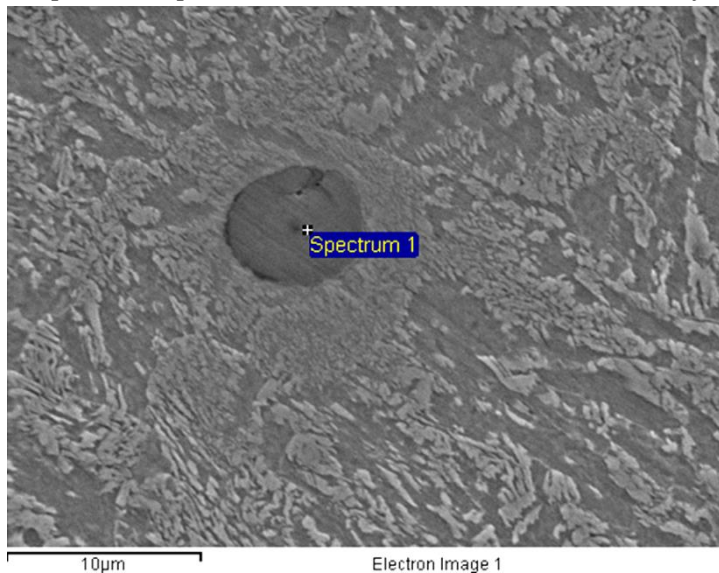
**Figure 15**

*Elliptical shaped inclusion showed (a) that was identified as manganese sulphide.*

Element	Weight %
S	37.64
O	6.15
Mn	52.55
Fe	3.66
Totals	100.00
